J.MORITA MFG.CORP.

Developed and Manufactured by **J. MORITA Mfg. Corp.**

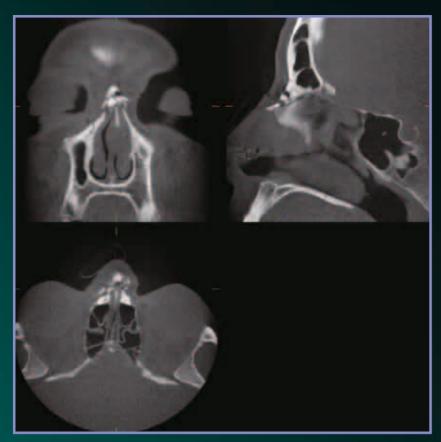
A severe nasal bone fracture with destruction of the soft tissue. Other midfacial fractures could not be found. Nasal piercing on the left side.

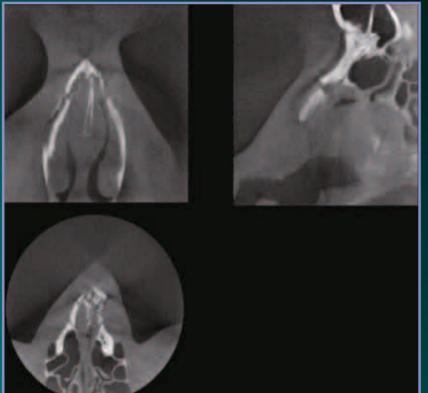
Nasal bone fracture.

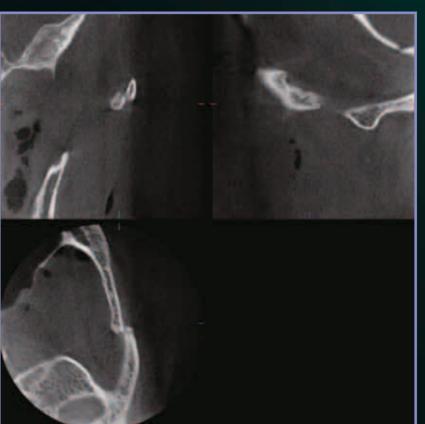
A fracture of the zygomatic arch with displacement of the fragments.
