## **3D IMAGE CLINICAL CASES - ENDODONTICS**

Supervised by Yoshinori Arai, DDS, PhD  
Professor Nihon University  
School of Dentistry

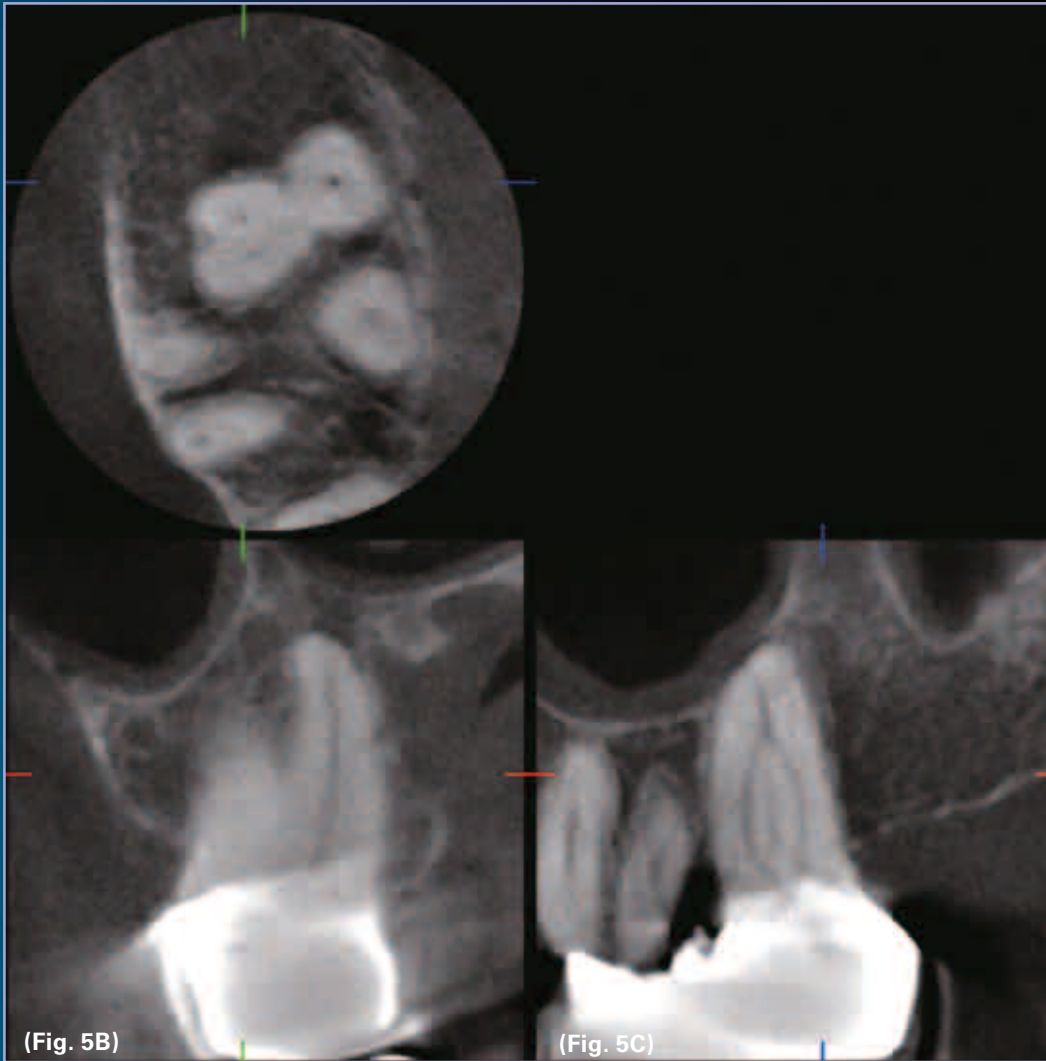
The patient presented below suffered from an irreversibly inflamed pulp in tooth #2, confirmed by prolonged thermal responses to cold and heat. Conventional radiographs revealed a fused root structure with little or no information about the root canal anatomy (Fig. 5A).

Accutomo imaging revealed that this molar had only three canals (reassuring), and that the two buccal canals merged in the apical third and bifurcated again (Figs. 5B & C). The post-operative conventional radiograph shows this anatomy treated out, with pre-informed anatomic knowledge (no looking for a fourth canal, knowing that the buccal canal merge apically—very unusual—and with adequate time committed to the irrigation process that allowed a three-dimensional obturation of the apical bifurcation of the canal system after the confluence (Fig. 5D).

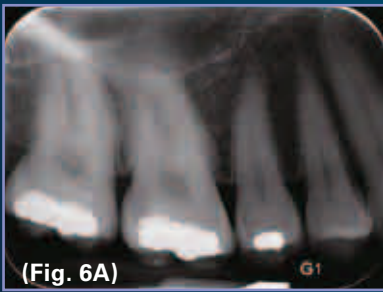
The patient presented with an irreversibly inflamed pulp in tooth # 3, confirmed by cold and heat testing (prolonged responses). Conventional radiographs revealed mesio-buccal root anatomy that was very curved, with the disto-buccal and palatal root anatomy appearing fairly straight (Fig. 6A).

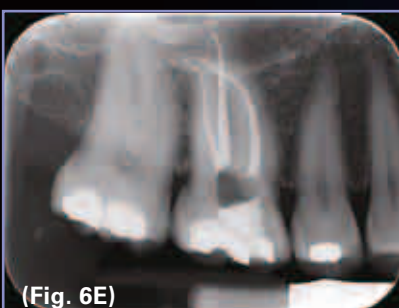
Accutomo CT imaging revealed a different story, allowing me to tread carefully during treatment (Figs. 6B.). The first bit of important information was that this tooth unusually had only three canals (Fig. 6C).

The second piece of very important information was that the curvature of the mesiobuccal canal was truly awe-inspiring (Fig. 6D). The third piece of information saved my self respect and the patient's tooth from a broken rotary file, it revealed a severe canal curvature—in the normally-hidden buccal plane (Fig. 6E),. Treatment, as a result was quick and sure with an exceptional (sorry, but it's true) result (Fig. 6E).

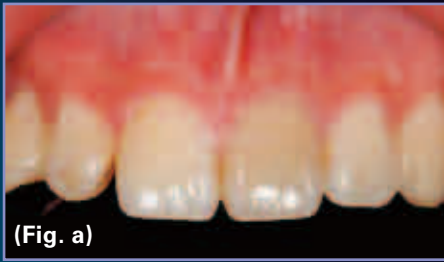
a. b. The first examination. A 20 year old male. The chief complaint was the discoloration of the crown of #9 and slight pain. External resorption from the palatal aspect and LEO were found. He has an experience of subluxation of the involved tooth 3 years ago.

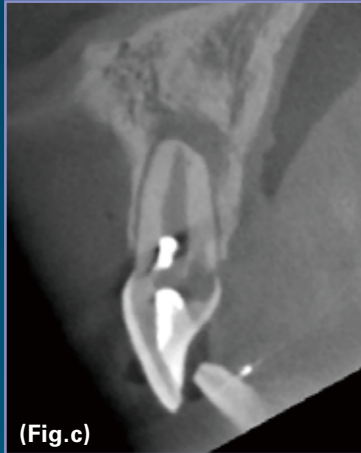
c. d. CBCT appearances. c: sagittal. d: axial. The root resorption start from the cervical area on the palatal aspect and invaded into the dentin.

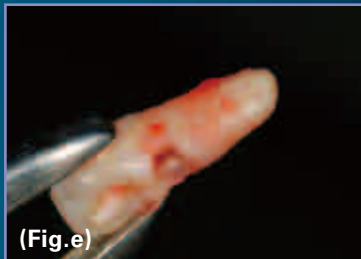
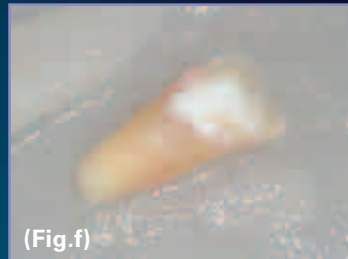
f. The trimmed #9. 2-3mm of the apex was cut off and the apical foramen was retro-filled with light curing GIC. The crown portion was cut off obliquely.

g. Just after the surgical extrusion. The root was rotated 180 degree. The fixation was only with the suture strings. Surgical dressing was applied for the first two days and the suture was removed 4 days after the surgery. No other splinting was performed any longer.

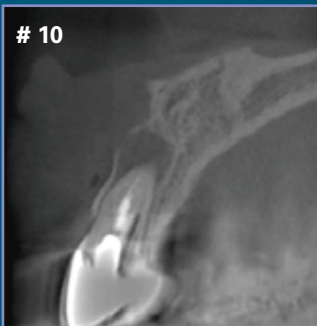
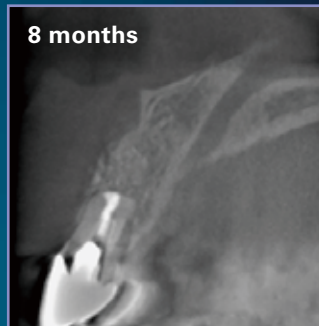
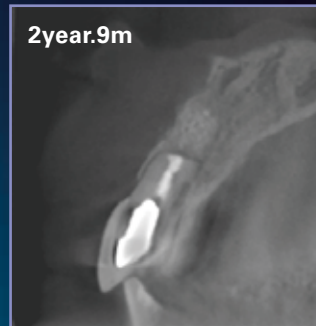
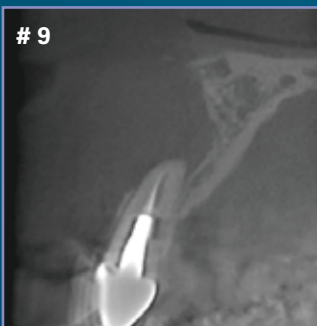
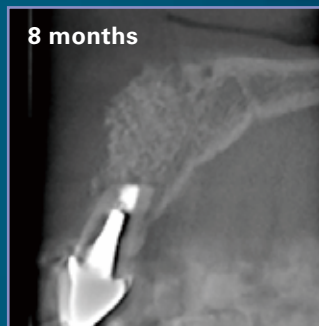
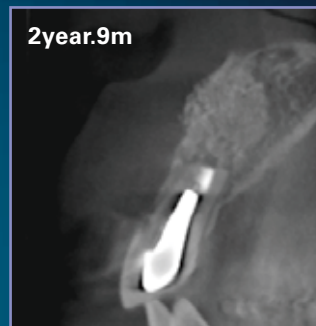
**3mm of each apex was cut off and the bony defect was filled with Bio-oss after the retro-fillings. The healing of the involved teeth was followed up with CBCT.**

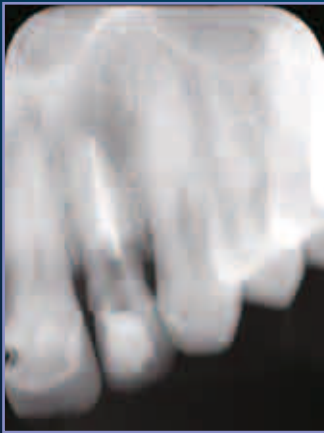
The periapical and panoramic radiographs show an “acceptable” endodontic treatment reaching the slightly lateral apex of tooth # 10. The endodontic filling lateral appears to be “doubled”, giving the impression of the presence of two canals. Ill-defined periapical radiolucency is noted slightly on the distal aspect of the apical third.

Cone beam images show that the gutta percha is perforating the facial aspect of the root and the buccal cortex. Some gutta perch is found in the canal but it is not reaching the apex.

Periapical radiograph is a 2d presentation of a 3d object; it collapses all the structures in the examined area in one plane. The image of the gutta percha is projected over the image of the root giving the impression of an acceptable treatment.

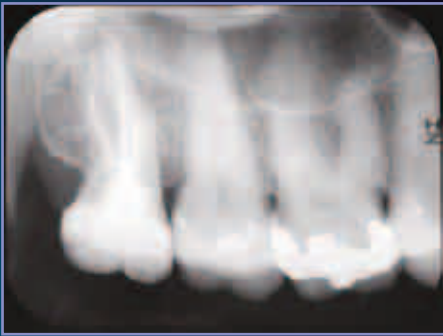
The periapical radiograph shows a well corticated, 3-4mm periapical radiolucency onto the second molar. The tooth is endodontically treated and the endodontic filling material is homogenous, well condensed, and reaching the apex.

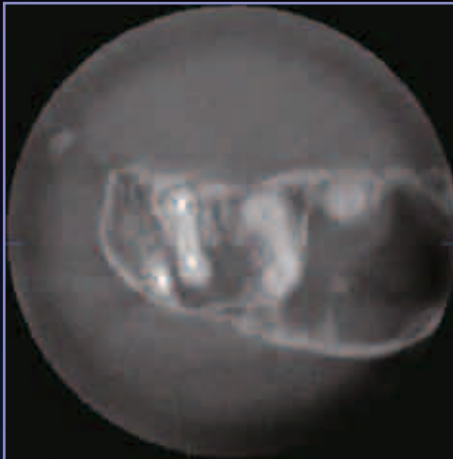
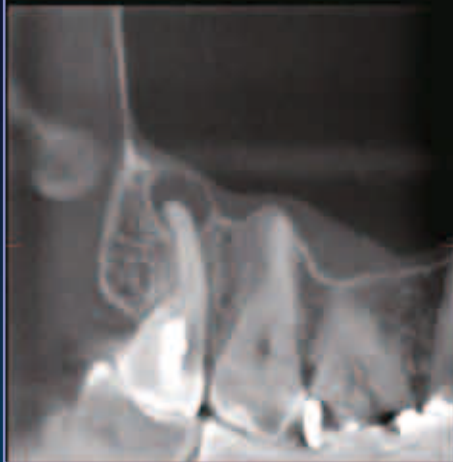
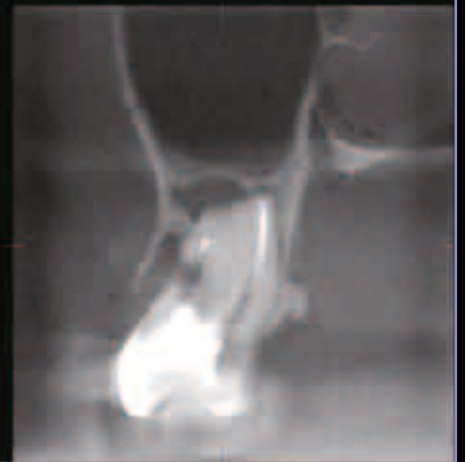
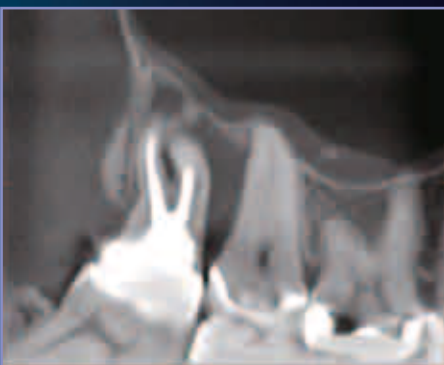
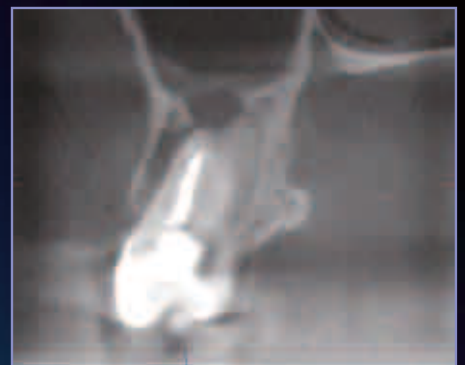
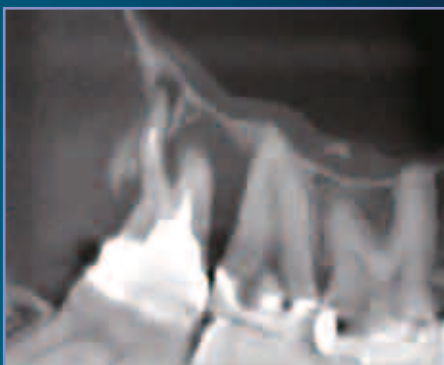
On the cone beam CT, the periapical lesion presence is confirmed with the presence of a severe vertical periodontal bone loss reaching the apex of the tooth in the form of what we call "endo-perio" communication. This finding was not seen on the periapical film due to the projection of the buccal and palatal thick cortical bones over the image of the periodontal lesion.

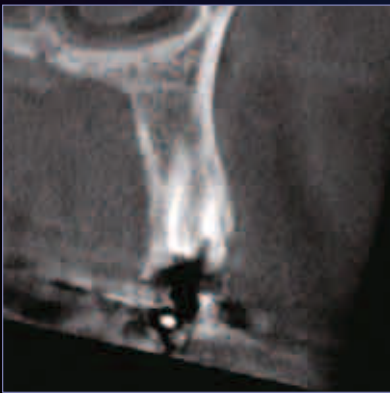
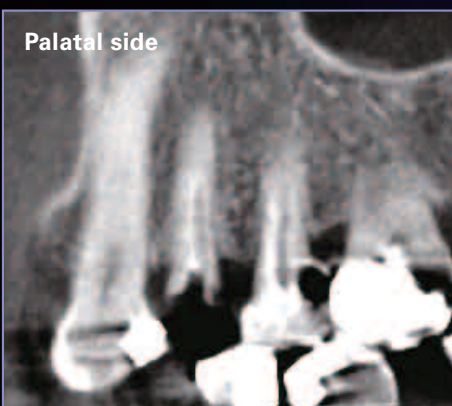
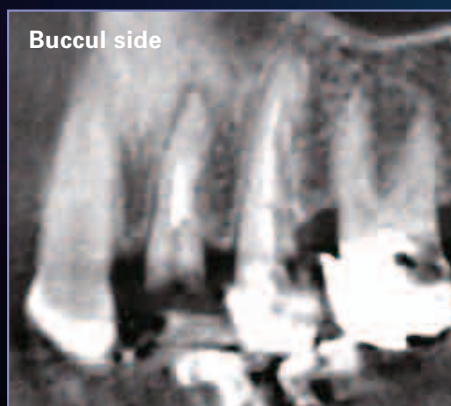
The patient was complaining of diffuse pain over the left maxilla. Conventional radiographs did not reveal pathological changes in the periapical region of premolars and molars. A Veraviewepocs 3D scan shows an air-filled, healthy, maxillary sinus and a periapical lesion at the apex of the buccal root of the first premolar.

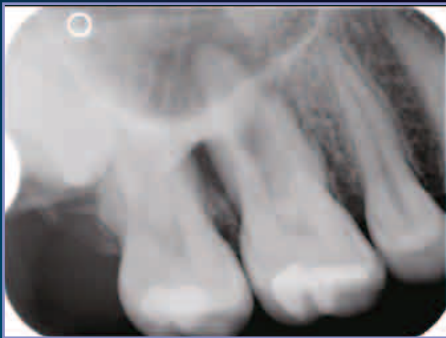
An endodontist had taken several images of the upper right molar region on a patient who presented with pain. He could see that a lesion was present at the first molar, but was uncertain about its extent.

The Accutomo images showed a lesion with a very large extent in all directions. It has caused a break-down of both the buccal and palatal cortical borders. It extends into the lateral part of the nasal cavity and the lower part of the maxillary sinus where a reaction is seen in the mucosa. The lesion also involves the root system of the second molar and gets very close to the unerupted third molar. None of this could be anticipated from intra-oral radiographs alone.

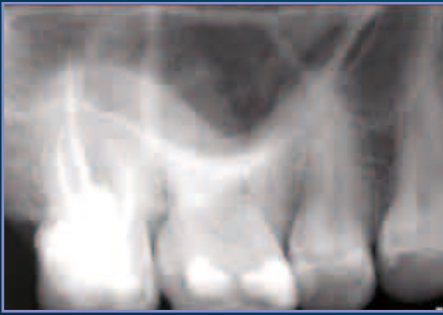
Although having taken several intraoral radiographs, an endodontist still felt uncertain about the conditions at the upper right second molar from which the patient still felt some pain after an endodontic treatment had been completed.

The Accuitomo images show lesions at the two buccal roots and at a palatal root, but also that a second palatal root exists in which the root canal has not been treated. In addition, a lesion is seen in the interradicular area between the latter and the mesiobuccal root. The lesion at the buccal roots extends into the lower part of the maxillary sinus in which a thickening of the mucosa can be seen.

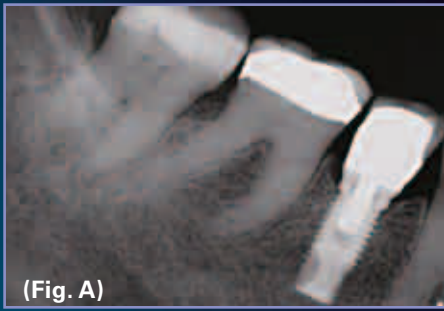
Clinical examination of the LR5, LR6 and LR7, revealed no abnormalities with no tenderness to palpation at the buccal and lingual root apices and no tenderness to percussion of any of the teeth. Vitality testing could not be carried out at the LR6 as the crown margin was subgingival. The LR7 predictably did not respond to the electric pulp test. The periapical radiograph (Fig. A ) revealed widening at the periapex of the LR7 with no other signs of pathology.

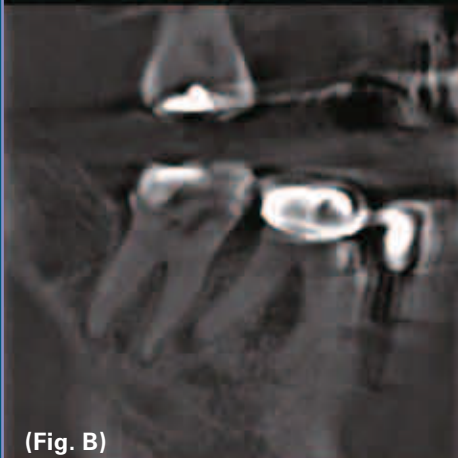
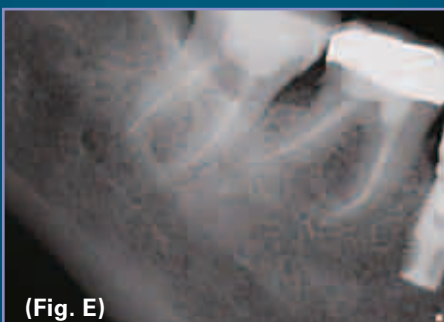
The sagittal slices of the microCT scan (Fig. B) however clearly showed a 4mm circular lesion associated with the apex of the distal root of the LR7. The reason why this could not be seen on the periapical radiograph could be understood from the coronal slice (Fig. C) that shows the lesion positioned entirely in cancellous bone and not involving the cortical plates – the prerequisite for visibility on a standard periapical radiograph. Furthermore the anatomy of the root canals in the LR7 could be visualized with there being clearly one mesial and one distal canal (Fig. D).

Without the microCT scan provided by the Veraviewepocs 3D, an attempt would have been made to find another canal in the LR7, as there was no reason to treat the LR6. Significant damage to the root of the tooth would have occurred before the search would have been abandoned, and the patient would still have been in pain following the procedure. With the scan, treatment was initiated immediately in the LR6 and the pain quickly eased. Endodontic treatment of the LR7 when completed, was done without further damage in an attempt to locate a second mesial canal (Fig. E).

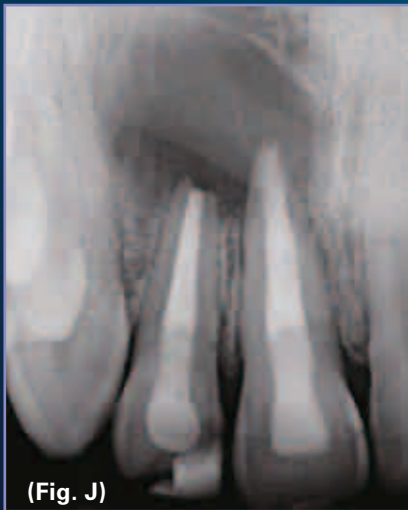
A 24 year old male patient attended 2 years following root canal therapy of his upper right central and lateral incisors (UR1 and UR2) with a draining buccal fistula (Fig. J). The teeth had been originally traumatised aged 10 and the apices were incompletely formed. On presentation with periapical infection aged 22 (Fig. F), the orthograde root canal treatments that were carried out had initially involved calcium hydroxide therapy followed by obturation with MTA apical plugs (Figs. G & H). Initial follow up at 6 months suggested some resolution (Fig. I), but the appearance of a fistula 18 months later confirmed regression and re-infection.

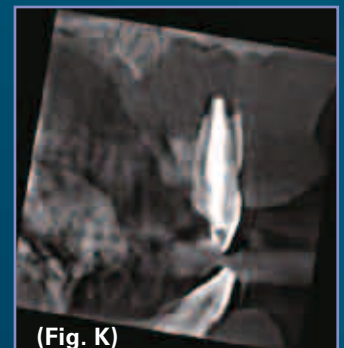
A microCT scan of the lesion using the Veraviewepocs 3D (Figs. K & L) revealed the true size of the lesion with both buccal and palatal plate perforations. The usual treatment of a recurrent periapical lesion with a satisfactory orthograde root filling would be buccal approaching periapical surgery with lesion curettage, apicectomy and possibly an apical retrograde seal. However, if this would have been carried out with such a lesion, soft tissue ingrowth from the palatal side would resist bony repair. True repair of a lesion of this size would require either a membrane on one side of the lesion to resist soft tissue ingrowth, or decompression followed by conventional surgery. Whichever is chosen, neither would have been immediately considered in a case such as this, and therefore, poor bone healing would have followed on from a standard surgical approach without the benefit of the microCT scan.

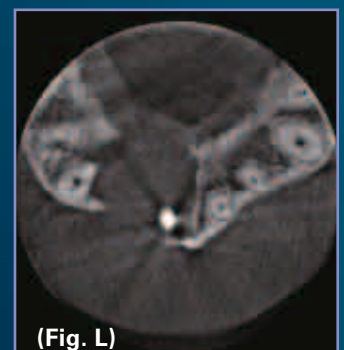
In this case a decompression procedure was carried out and a plastic drain was placed buccally (Fig. M & N) with the patient instructed to irrigate the underlying bony cavity with Corsodyl using a syringe. The drain stayed in place for 2 weeks and was then removed (Fig. O).

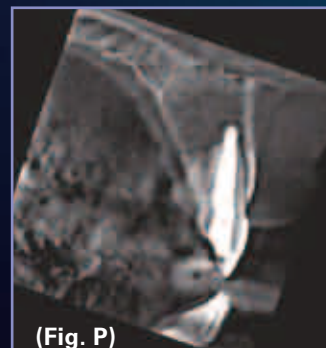
A microCT scan carried out after 6 months showed shrinkage of the lesion and full reformation of both buccal and palatal plates (Figs. P & Q). Although buccal approaching periapical surgery with lesion curettage and apicectomy was now possible, with the lesion asymptomatic and good healing it was decided to leave and observe further on the basis that marsupialisation of a true cyst might have occurred and contamination at the root apices were no longer an issue. A further review was scheduled for 1 year.

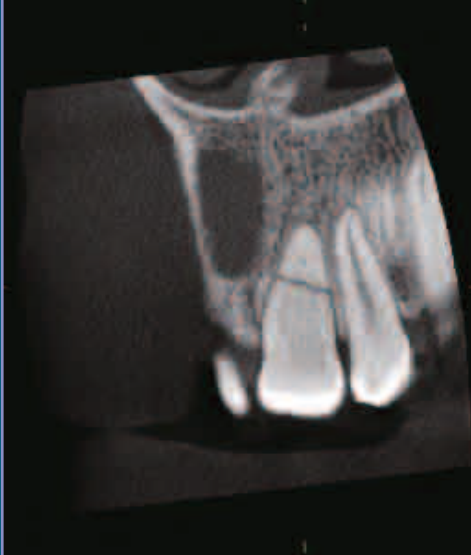
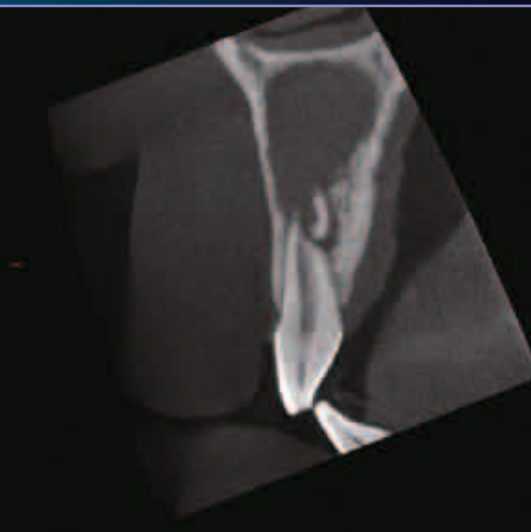
An Accuitomo examination of the upper frontal region demonstrates an upper right medial incisor with a very wide root canal. This can be seen in teeth that have become devitalized at an early age. At the apex of this tooth, a large cystic lesion can be seen. Its borders are not clearly defined and the surrounding bone is denser than normal. The lesion, thus, has the appearance of an infected apical cyst.

The examination also shows a fracture of the apical part of the right medial incisor.

In the left medial incisor, an almost horizontal root fracture is seen. In both the apical and the coronal fragments, the pulp is almost completely obliterated.

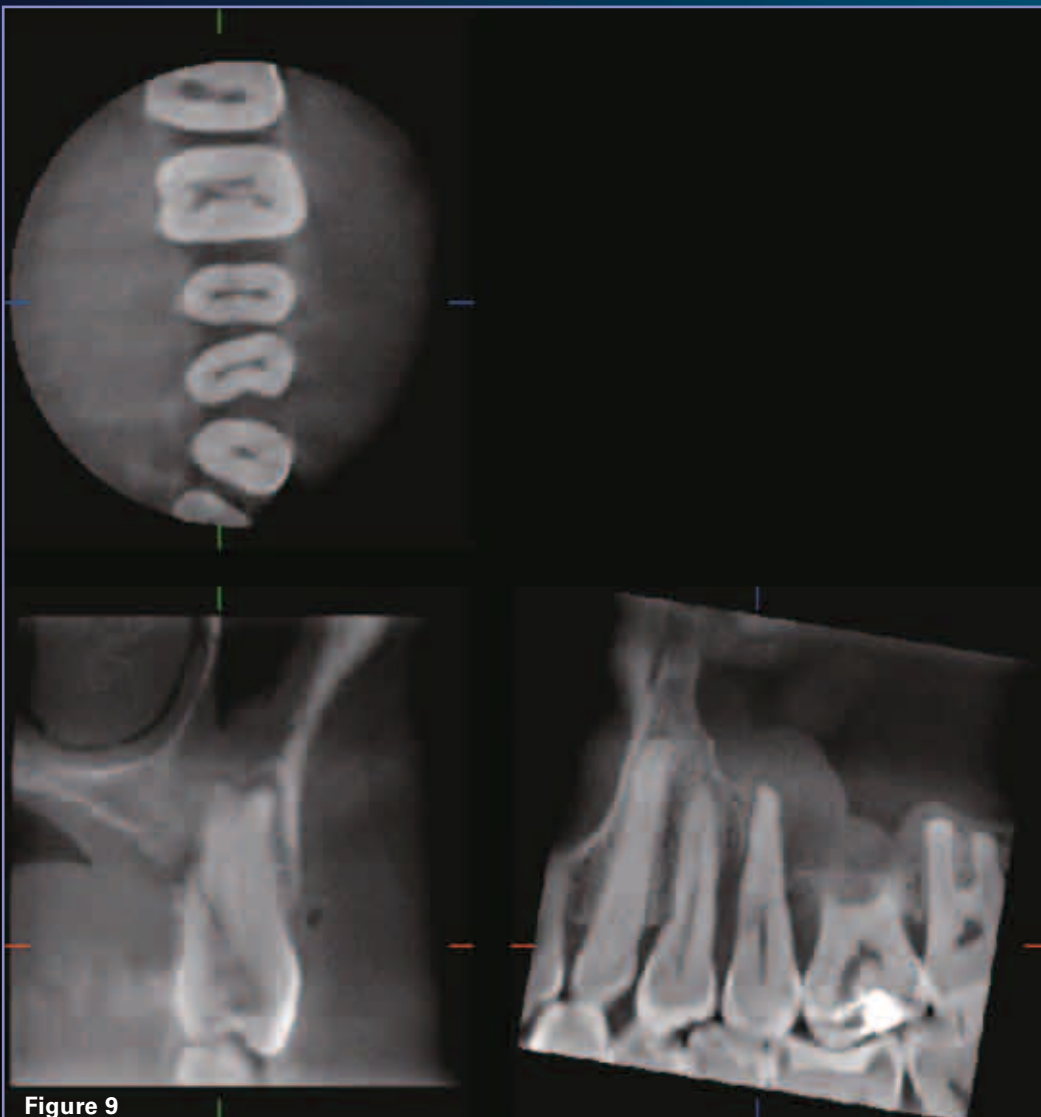
This 48 year old male patient complains of severe pain in the left maxilla that developed after eating. Panoramic (Fig. 8A) and periapical radiographs (Fig.8B) show a possible widening of the periodontal ligament space at the mesial surface of tooth #13. The Accuitomo scan (Fig. 9) clearly reveals an oblique fracture of the root of #13 that extends from the palatal surface of the root towards the buccal surface of the crown of #13. Interestingly, the fracture does not extend into the enamel, but appears to end at the area of the dento-enamel junction. There is also widening of the periodontal

ligament space along the fracture line. Finally, there is thickening of the mucoperiosteal lining of the floor of the left maxillary sinus consistent with maxillary sinusitis, that most probably is unrelated to the dental disease described above.

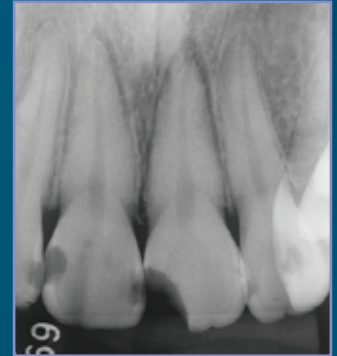
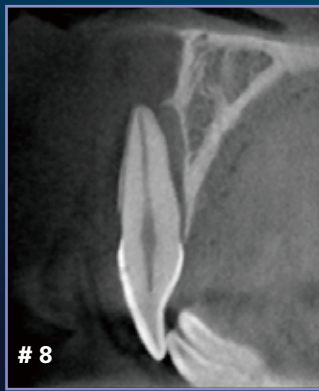
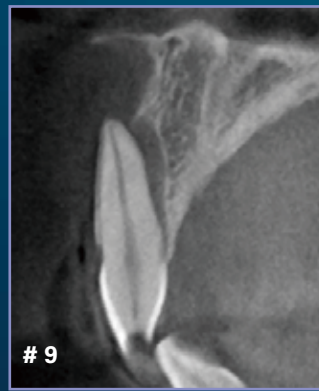
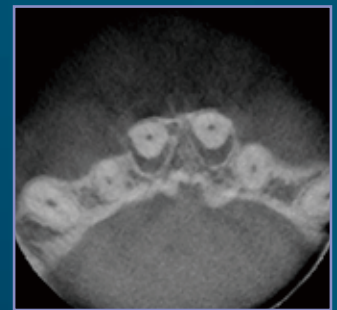
Before

A 23 year old female. Two central incisors are involved with lateral luxation, which is very difficult to diagnose with conventional methods, but is easily revealed with CBCT.

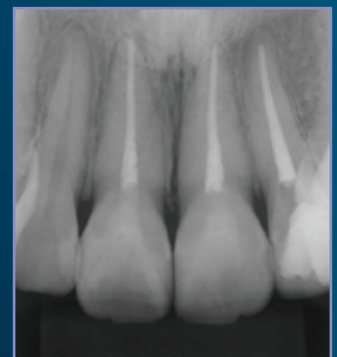
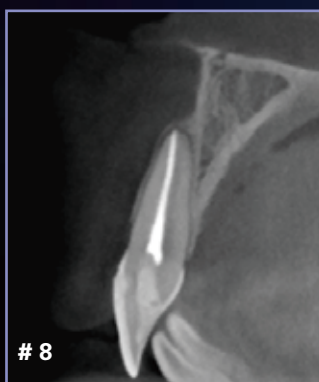
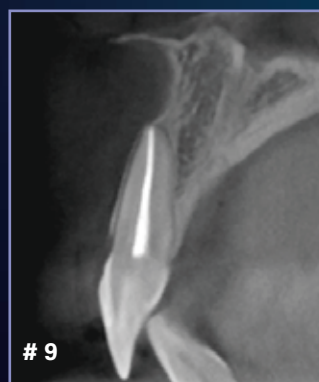
1 year and 3 months later<sup>1</sup>

One year 3 months follow-up result with CBCT has shown the complete healing.

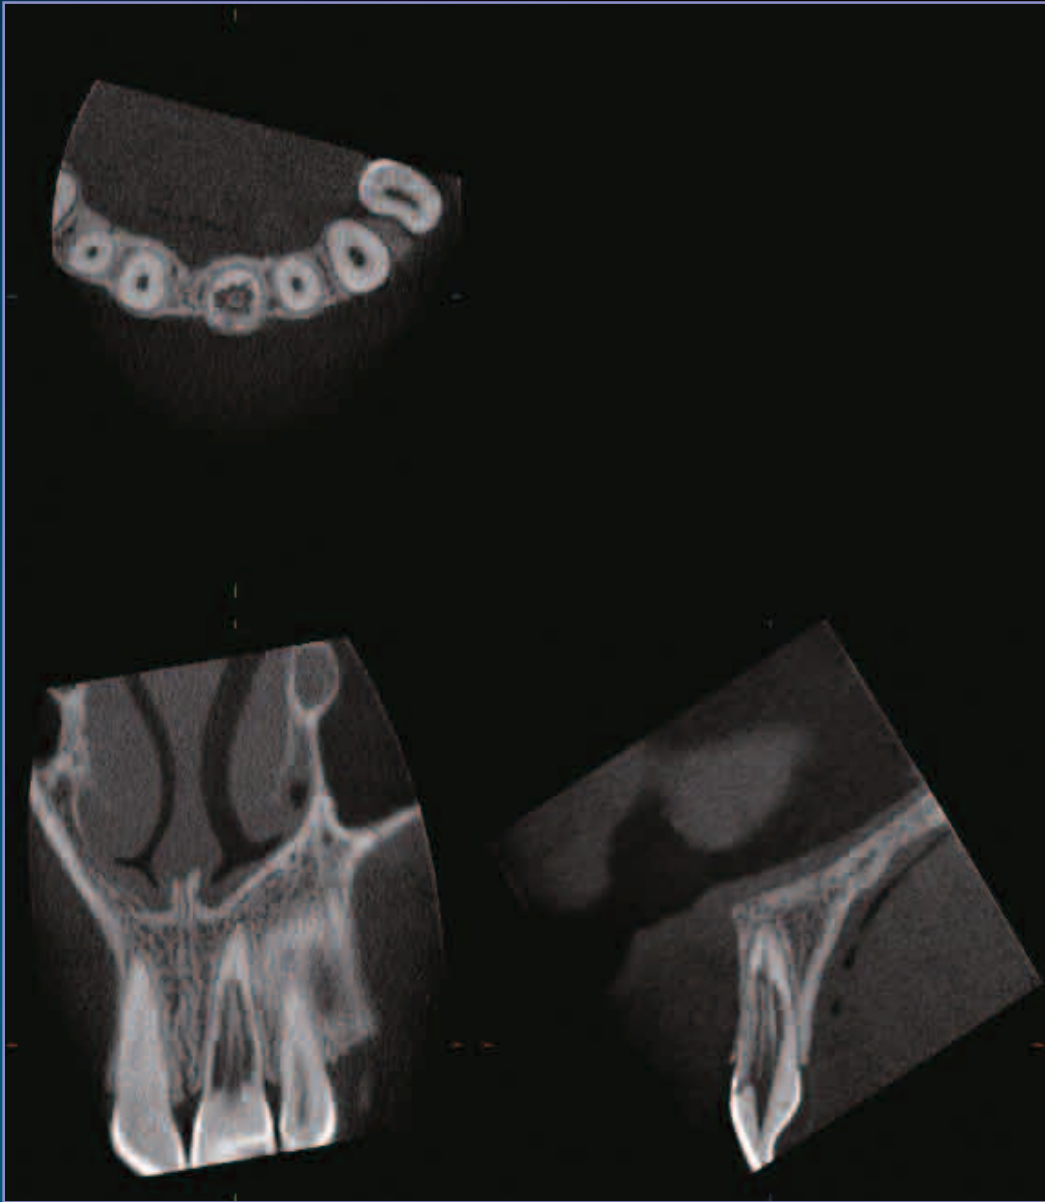
In a symptomless patient with known trauma to her upper left medial incisor several years ago, the Accuitomo examination shows a severely resorbed tooth. The images demonstrate the clarity with which resorptions now can be studied. Note that the walls of the pulp still remain and that there is a lack of buccal bone at the middle of the root. In all likelihood, the origin of this resorption is external rather than internal.

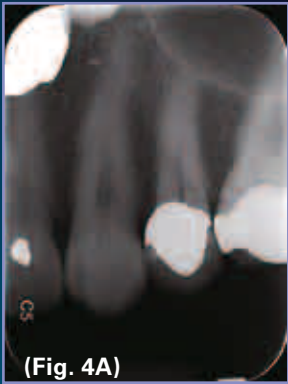
The patient presented with pain to palpation over tooth #11. Vitality testing revealed that the tooth was vital. The conventional pre-operative radiograph showed an unusual appearance of the root canal space just apical to the CEJ (Fig. 4A).

All periradicular bone appeared to be normal. Accuitomo imaging revealed (Figs. 4B & C) a large internal/external resorption defect on the buccal surface of the root just above the osseous crest of bone, dictating extraction. Typically, treatment of this tooth would have been instituted, wasting the patient's time and money when the tooth was hopeless.

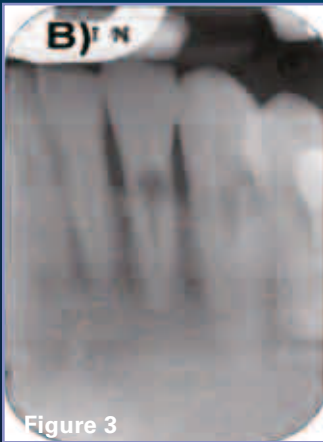
Fig. 3 shows the panoramic (Fig. 3A) and periapical (Fig. 3B) radiographs of a 54 year old asymptomatic male patient. These radiographs, taken during a routine dental examination, reveal enlargement of the pulpal cavity of teeth #22 and 23, consistent with internal resorption. However, these radiographs do not offer any information regarding the extent of the resorption and thus do not aid in the treatment planning (i.e. endodontic treatment vs. extraction) of the patient. Clinical examination was unremarkable. An Accutomo scan delineated the extent of internal root resorption in both teeth. Interestingly, in addition to the internal resorption, external resorption at the cervical area of both #22 and #23 was observed. Based on the extent of the internal and presence of external root resorption the teeth were deemed unrestorable.

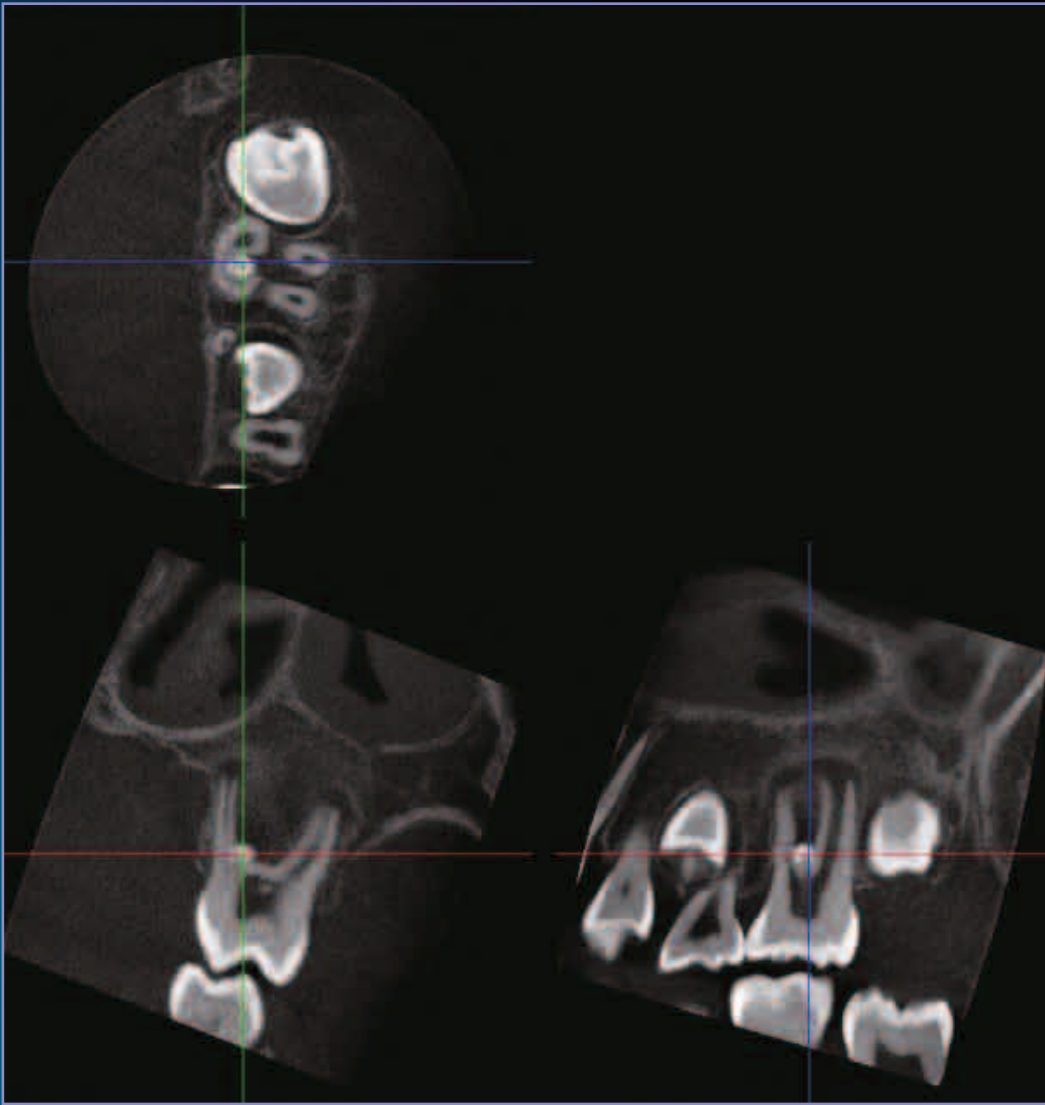
This young girl presents with pain localized to the upper left first molar region. The accutomo examination reveals the presence of an enamel pearl in the palatal part of the interradicular area. There are two palatal roots that become fused as they come close to the crown forming a crescent shaped curvature in which the enamel pearl is found. The sagittal image (lower right image) shows the two palatal roots. In the interradicular area, and surrounding the enamel pearl, a lesion is found. In addition, the apical parts of the roots are surrounded by a denser than normal bone indicating an inflammatory reaction.
